Analysis on corrosion fatigue cracking mechanism of 17-4PH blade of low pressure rotor of steam turbine

Accident unit was put into operation in September 2016. The steam turbine (Model: CLN350-24.2/566/566) is supercritical, primary intermediate reheat, single shaft, single back pressure, wet condensing steam turbine produced by Harbin steam turbine works Co., Ltd., which has the operation capacity of steam extraction with heat supply. The unit has started 12 times since it was put into operation, and entered into overhaul in late June 2018.

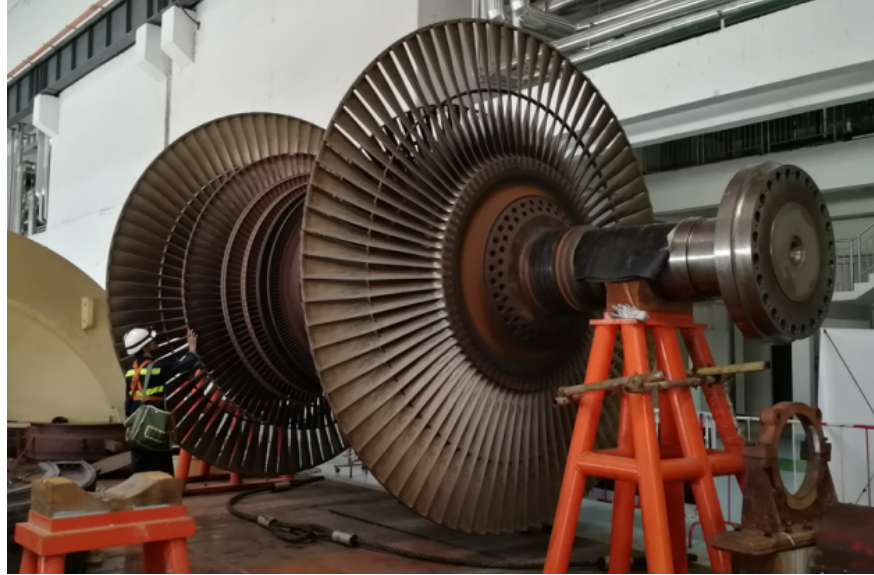
Fig. 1 The last stage blade

The blade with cracks is the second last stage blade of low pressure rotor of 350MW supercritical unit(Fig. 1), made of 17-4PH (China brand 05Cr17Ni4Cu4Nb), which is a martensitic precipitation hardening stainless steel with solution + aging. During the overhaul in July 2018, it was found that 80 of the 98 moving blades of the second last stage of low-pressure rotor had cracks near the root, near the top and in the middle of the blade back arc.

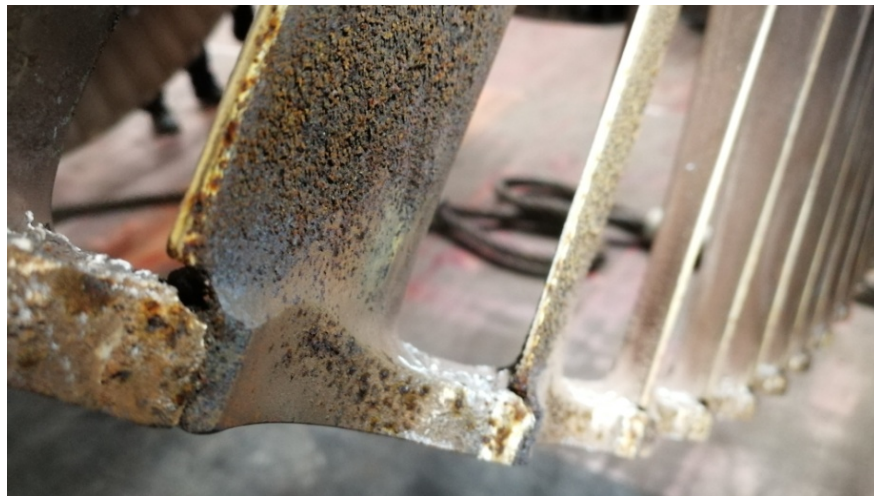
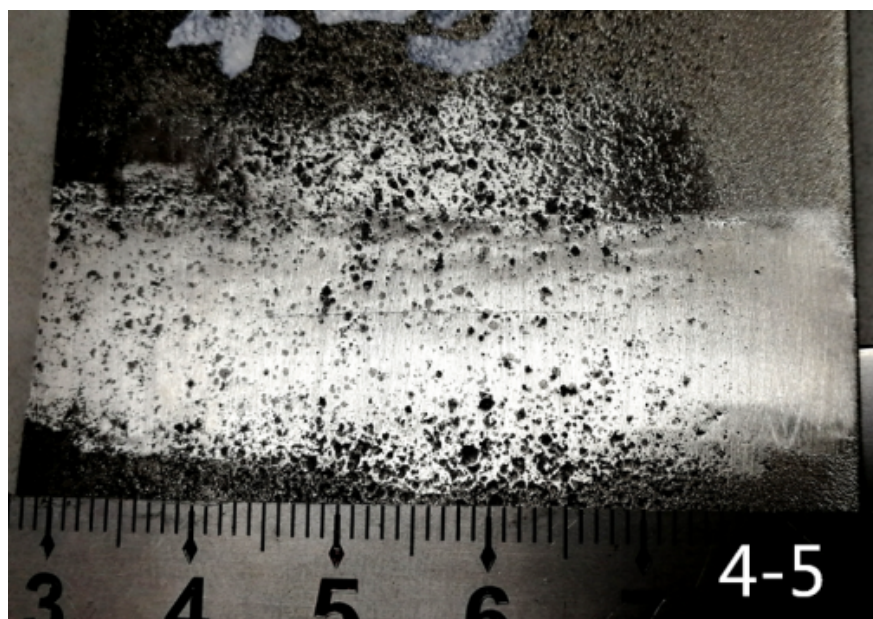
Fig. 2 Surface corrosion of last stage blade

Through inspection, it is found that there is corrosion of different severity on the surface of blades, and there are a large number of obvious corrosion pits, the second and last stage blades are the most serious. Water erosion was also found on the last stage blade (Fig. 3). The water erosion on the edge of the blade has both physical and chemical effects. The defect appears near the top of the inlet side and the root of the outlet side, with a depth of less than 1mm. There are 80 cracks near the root, near the top and in the middle of the blade back arc in 98 moving blades of the last stage of low pressure rotor. According to the location and general shape of the cracks, it can be divided into three types: the first type cracks of near root(Fig. 4 C): mainly distributed in the back root of the blade opposite to the steam face, the cracks are relatively obvious, some cracks are visible to the naked eye after sandblasting, and the trend is vertical to the direction of the maximum normal stress. The second kind of cracks in the middle of blade back arc(Fig. 4 B): the cracks are relatively thin, short and shallow, all appear on the back arc surface, which can be found through magnetic particle inspection, and the direction is perpendicular to the direction of the maximum normal stress. The third kind of near blade top crack(Fig. 4 A): mainly distributed in the variable cross-section of blade tip, and the direction of crack is generally perpendicular to the direction of maximum normal stress. This kind of crack is mainly found in the forward blade of the second last stage.

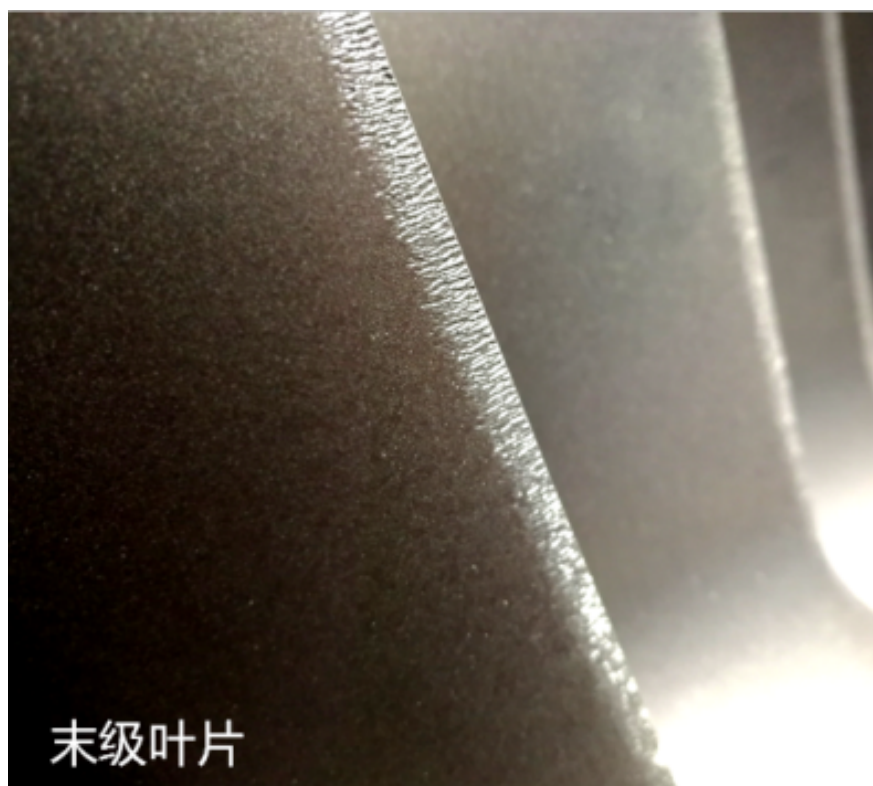
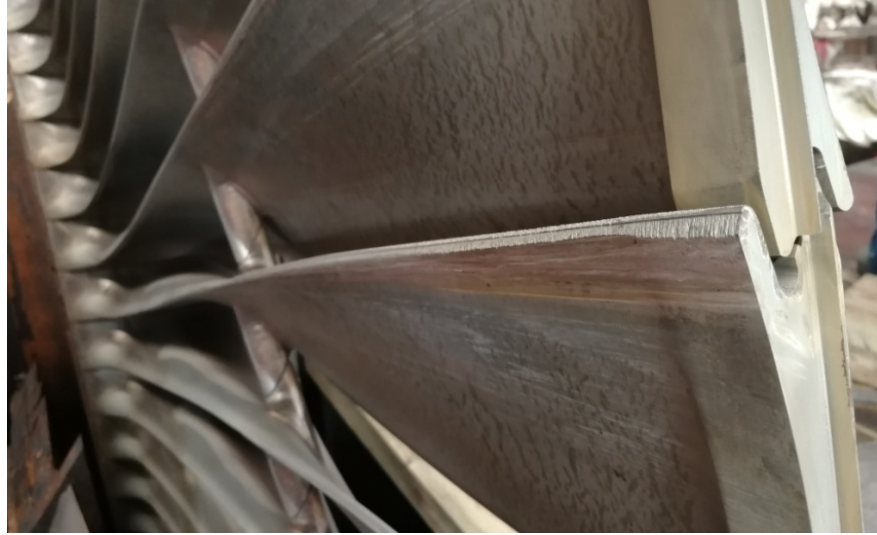
Fig. 3 Water erosion of last stage blade

Blade cracking originates from corrosion pits on blade surface or water erosion on blade edge. As a result of water erosion, a sharp groove which changes the stress state of the blade surface is formed at the edge of the blade, and makes the crack appear and expand more easily at this position. Pitting is considered to be the precursor of corrosion fatigue damage again and again, which has been proved by many blade failure analysis [10-15]. Pitting not only reduces the actual strength of blade, but also leads to stress concentration, which can become the core of crack in the range of low cycle stress. The formation of corrosion pit begins

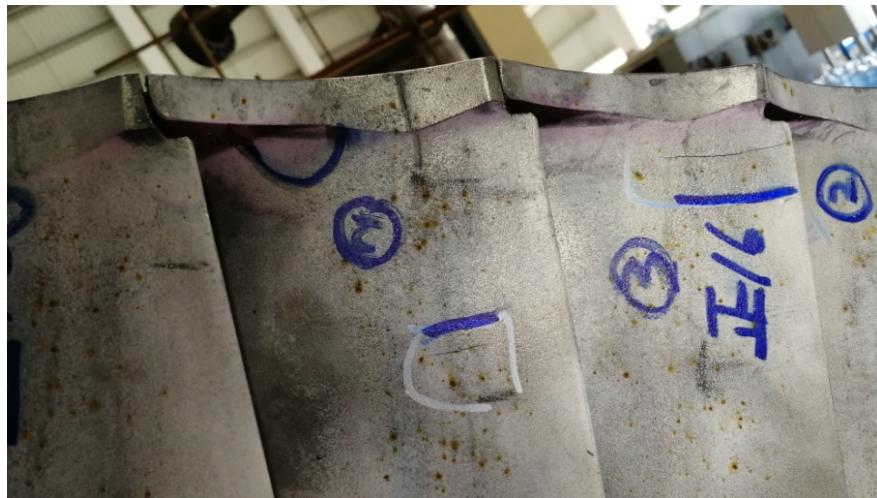
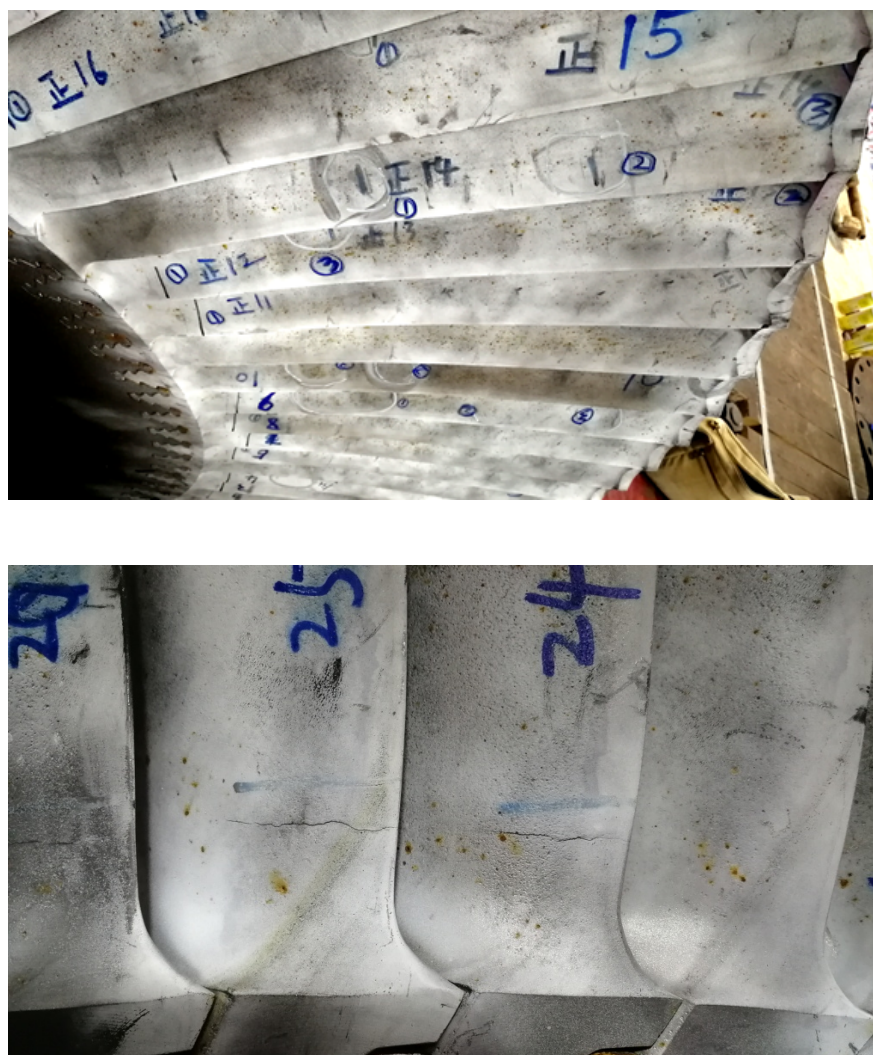
Fig. 4 A:Cracks on the top of blade,B:Cracks in the middle of blade,C:Cracks at blade root

Three kind of cracks were found in the 4#blade: near the root, middle and near the variable cross-section of the top. 4-6 cracks were taken as the research object.

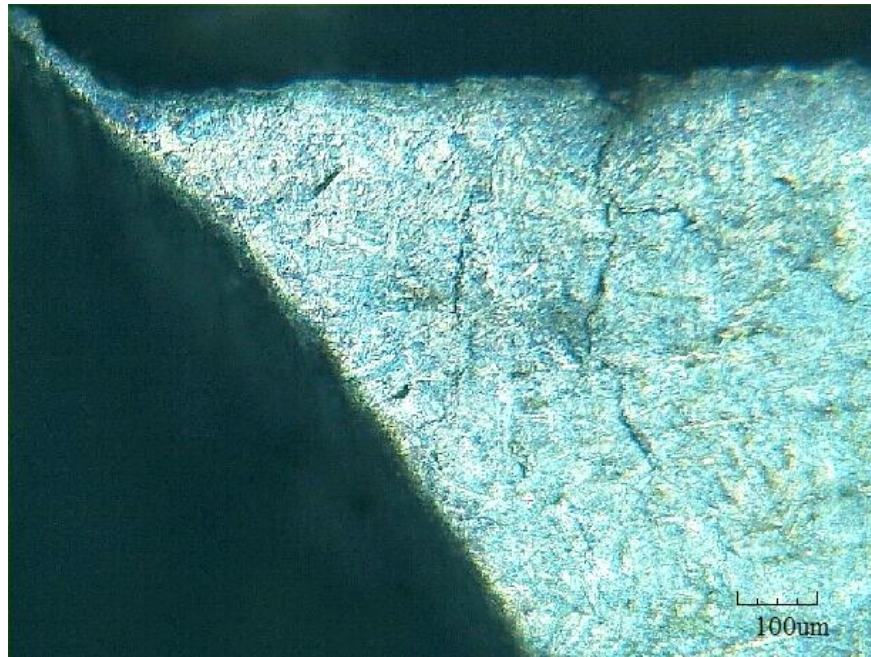
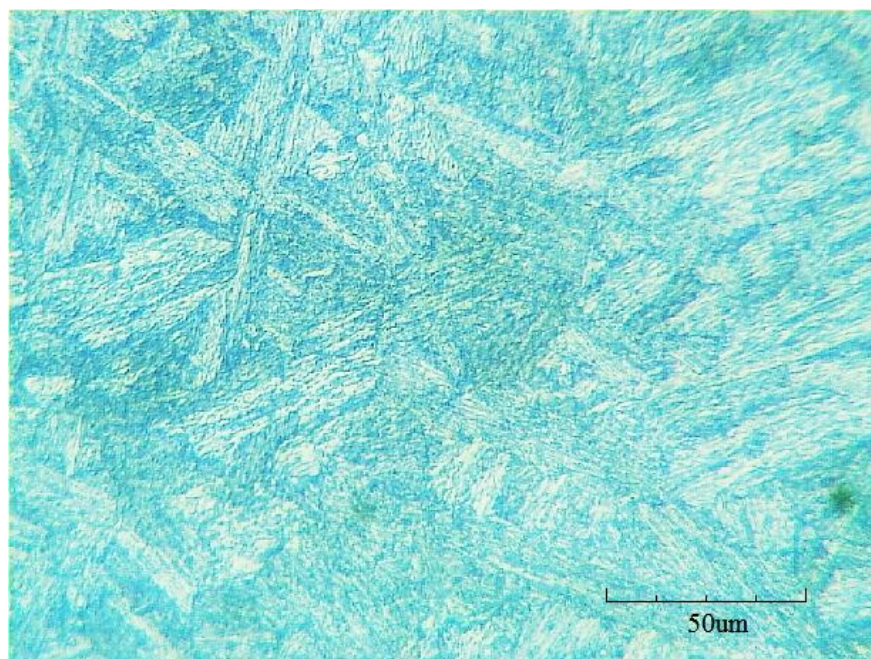
According to GB /T13298-2015 *Test method for microstructure of metal* , after mechanical polishing, picric acid + hydrochloric acid are used for erosion, and then metallographic analysis is carried out for the cracked blade section. The microstructure was analyzed by metallographic microscope and scanning electron microscope(SEM). The results(Fig. 6, Fig. 7)show that the microstructure is low carbon martensite + dispersed intermetallic strengthening phase, the matrix structure is normal, and there are many fine branch cracks along the grain near the main crack.

Fig. 6 Metallographic structure of 4-6b section

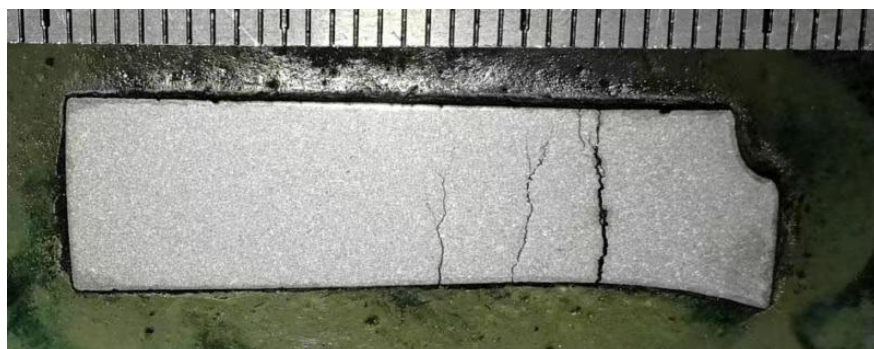
Fig.8 Macro crack morphology

As shown in Fig. 8, a large number of cracks (1#,2#,3#) were found in the scanning area at low magnification. All the three cracks originate from the corrosion pit. However, the crack initiation and propagation direction are different. Both 1 # and 2 # cracks originate from the corrosion pits on the lower surface of the blade, and the cracks propagate to the upper surface, forming many directional dendritic cracks near the crack end. 3# cracks are quite special. On the one hand, they start to expand upward from the origin of the

lower surface, and on the other hand, many secondary cracks originate from the corrosion pits on the upper surface and expand downward. The reason of the secondary cracks on the upper surface is inferred: because the main cracks are 40mm long and the opening is 0.8mm large, and they have already shown penetrability, the actual stress area of the blade is reduced, the local stress increases, and the alternating stress amplitude value will inevitably increase after the deterioration of the operation condition (the vibration of the shafting increases sharply after the occurrence of the first broken piece). In addition, there are corrosion pits on the upper surface to form the stress concentration, which are the total of these factors. Under the same action, a large number of secondary cracks are inevitable. The upper and lower surface cracks finally intersect and form a through crack. No matter the crack originates from the upper surface or the lower surface of the blade, it starts from the corrosion pit and extends in the opposite direction. Most of the cracks are along the original austenite grain boundary.

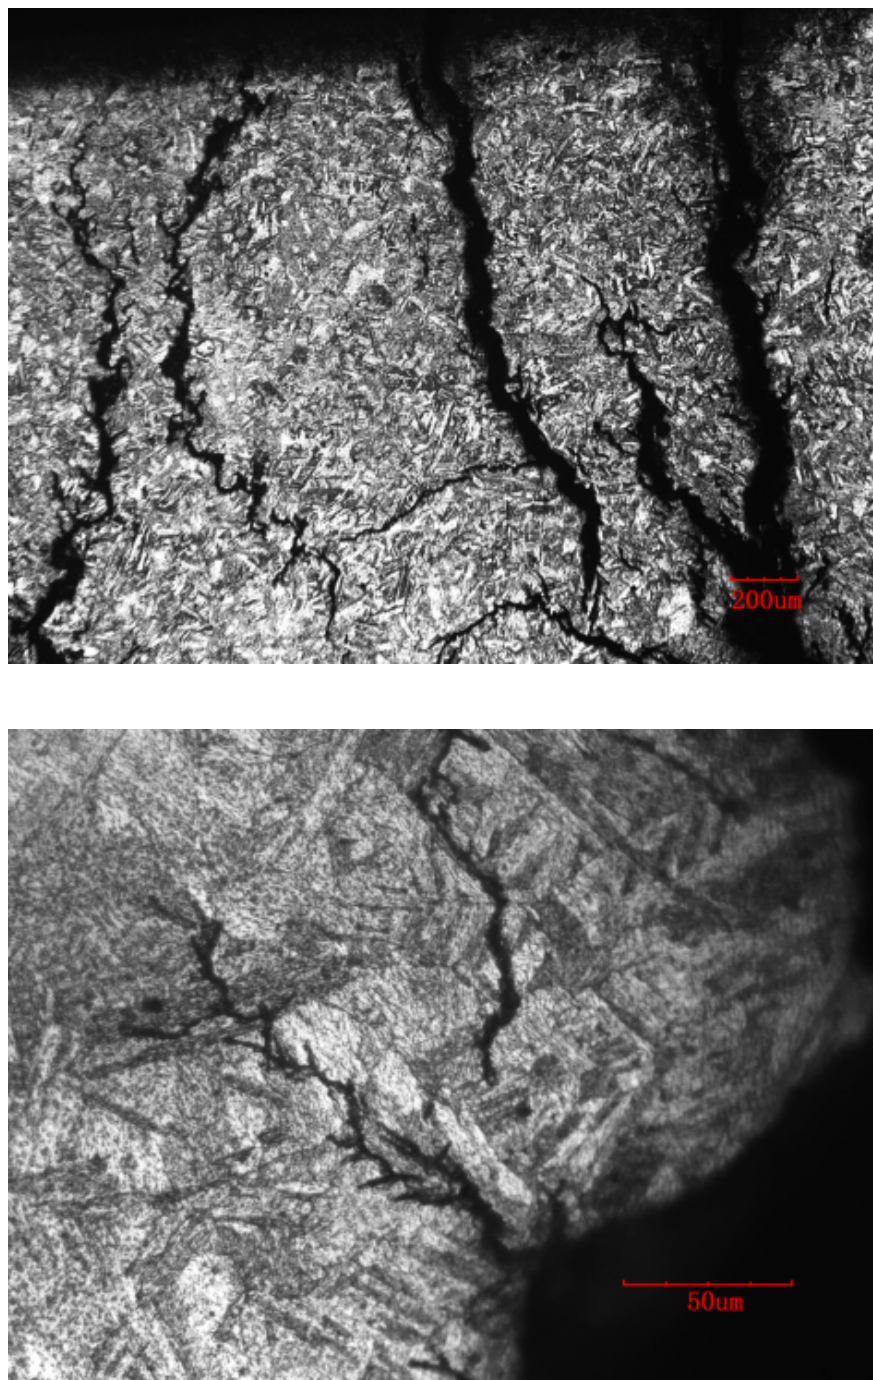
Fig.9 Microcrack morphology(Dotted area in Fig. 10)

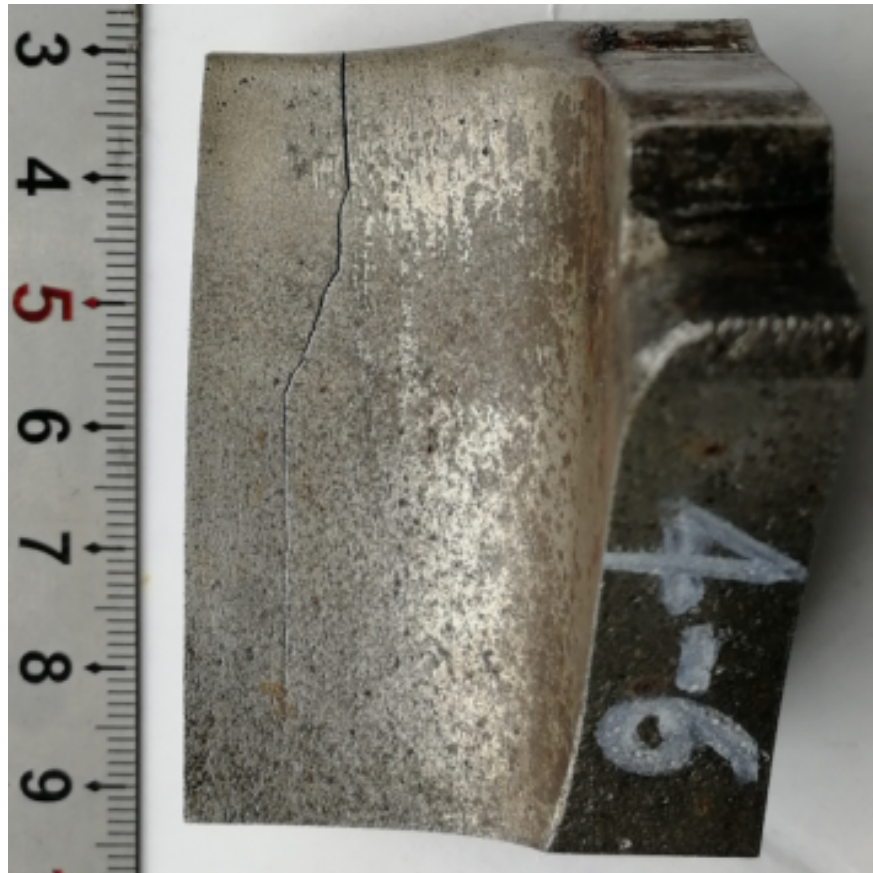
Fig. 10 Original surface not cleaned (after fracture opening)

As shown in Fig. 10, the crack length of sample 4-6 is 56mm, showing penetrability, and the crack direction is perpendicular to the main stress direction. 4-6a and 4-6b fractures were obtained after opening along the

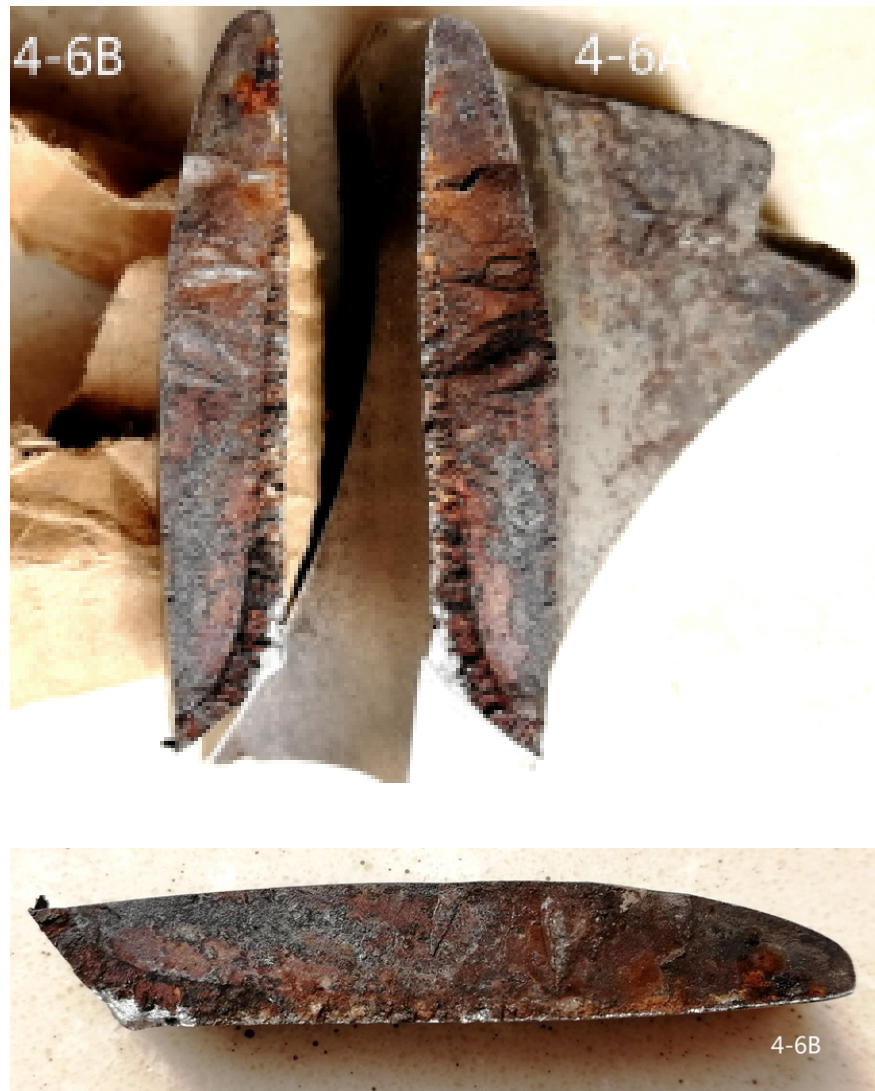
Fig. 11 The fracture after cleaning

As shown in Fig.11, the fracture crack origin area is located on the back arc surface about 20 mm away from the steam inlet side. The surface is rough and grainy, and there are a lot of small corrosion pits on the outer surface of the metal in the source area at low magnification. The crack propagates radially from the center of the source region to the center of blade, forming a relatively bright propagation region. It is found that there are many concentric arc lines (shell pattern) perpendicular to the crack propagation direction. It is the trace of plastic deformation along the line before the crack transient, and it is also the most basic macroscopic feature of the fatigue fracture. It can be concluded that there is no obvious stress concentration in the fracture. With the local change of crack growth direction, there are many radial fatigue steps which are perpendicular to the fatigue arc, which are the macroscopic plastic deformation traces left by the intersection of two different height fatigue cracks. Before fracture cleaning, it was observed that there was obvious corrosion product coverage in the source area and expansion area (as shown in Fig. 13). When the crack propagates to the vicinity of the inner arc through the center, an arc instantaneous fracture zone with a length of 50 mm and a width of less than 3 mm appears. The surface is gray and rough fibers, which is shown as a shear oblique fracture generally in the instantaneous fracture zone of ductile materials. It is worth noting that the area of the instantaneous fracture zone is small, which does not cause the blade fracture to fly off. The crack propagation direction is generally from the back arc to the inner arc surface along the thickness direction. The instantaneous fracture zone is generated when the critical size in the thickness direction is reached. Because the area of the extended zone is much larger than that of the transient breaking area (Fig.11), it can be inferred that the nominal stress of the fracture is relatively low.

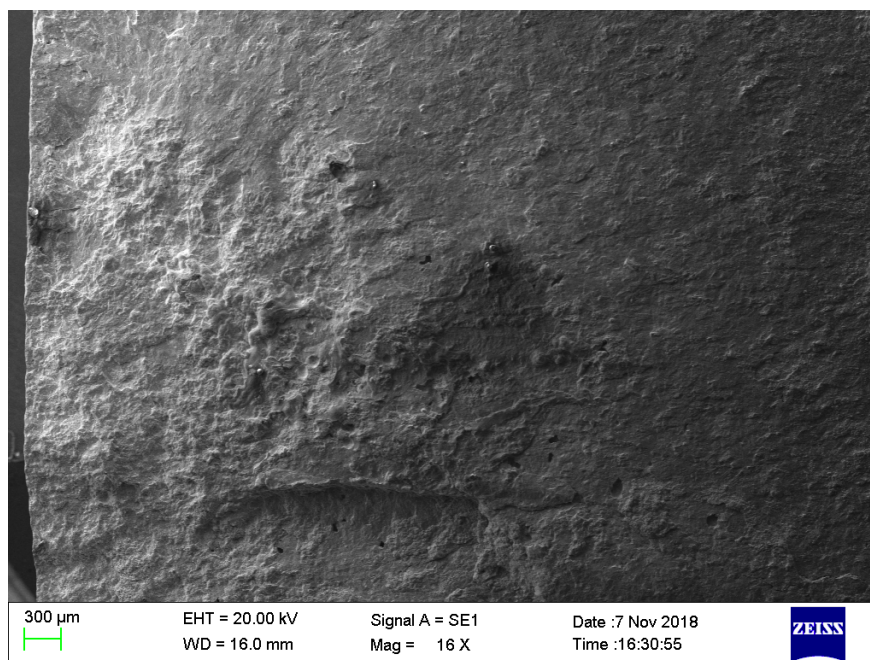
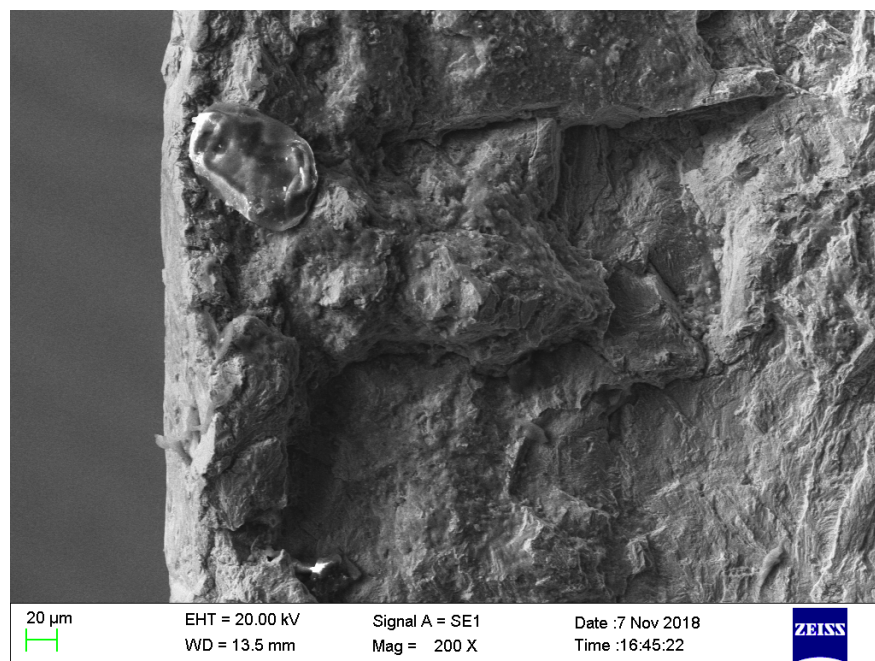
Fig.12 Morphology of crack origin area

As shown in Fig.12, the surface of the origin area is rough, and the striation is generally divergent, showing the micro morphology of cleavage. The red circle is the crack origin location.

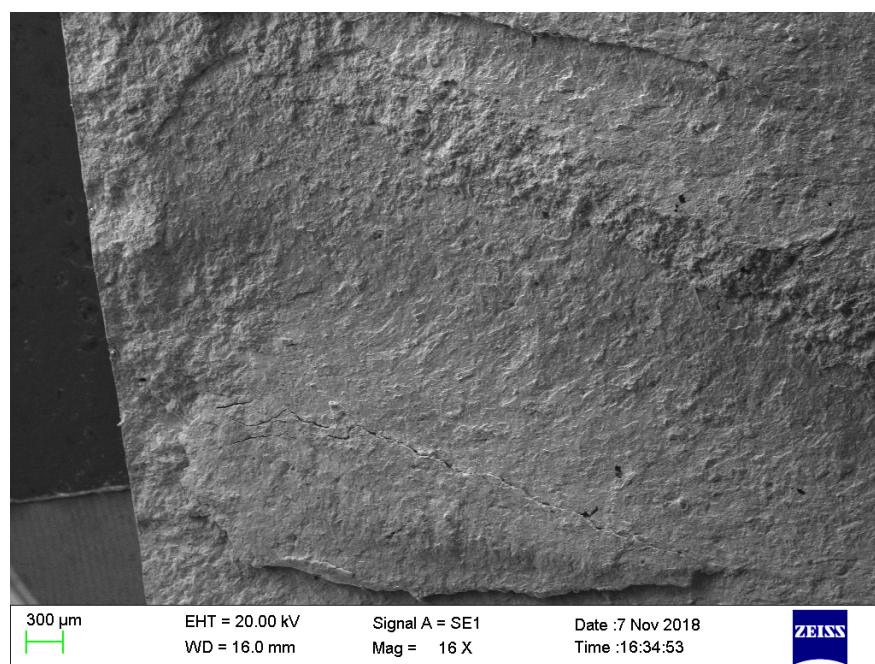
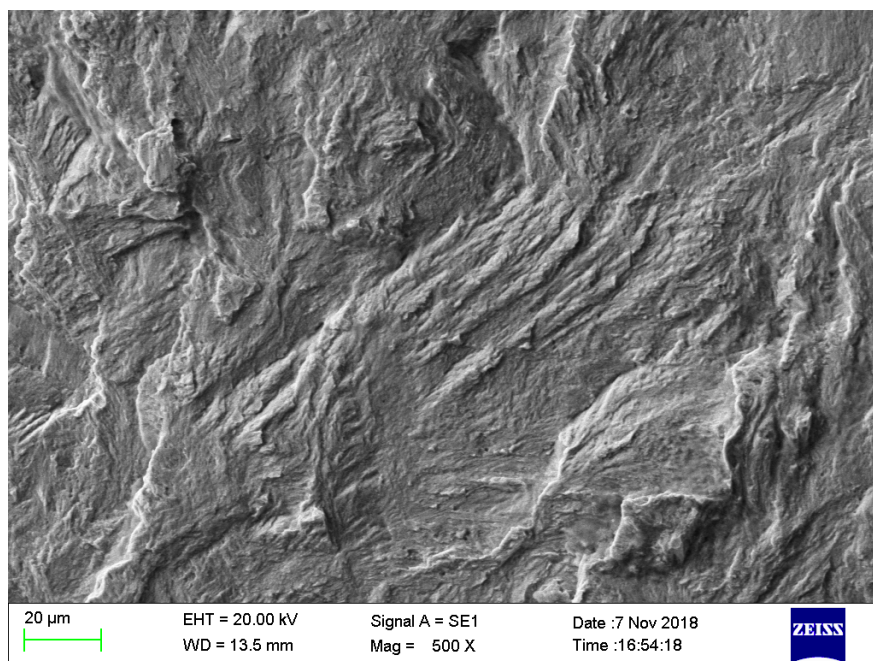
Fig.13 Crack growth zone with corrosion fatigue striae

The surface of the expansion area is bright (Fig. 13), showing river pattern, which is quasi cleavage micro morphology with obvious stripe fatigue striae.

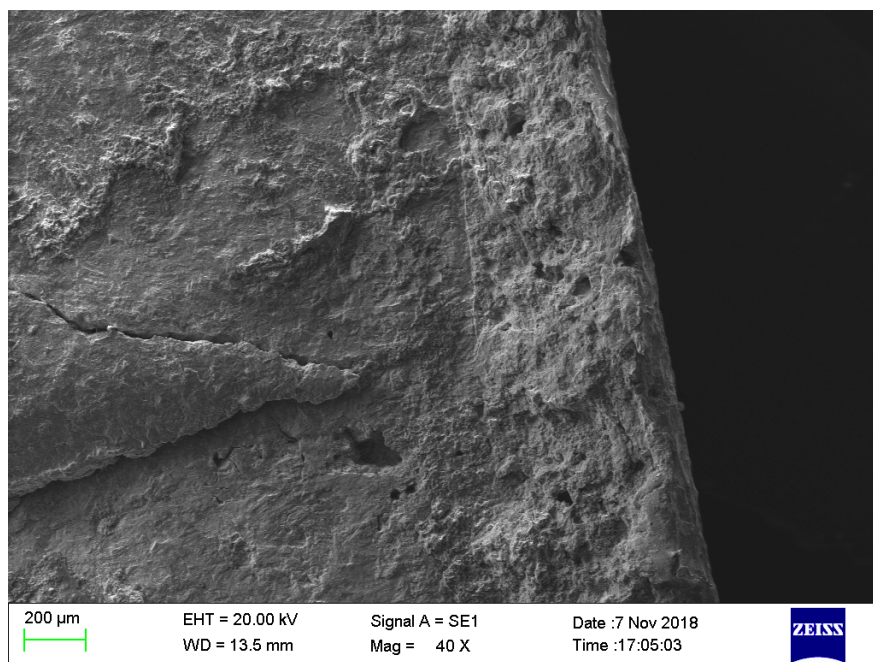
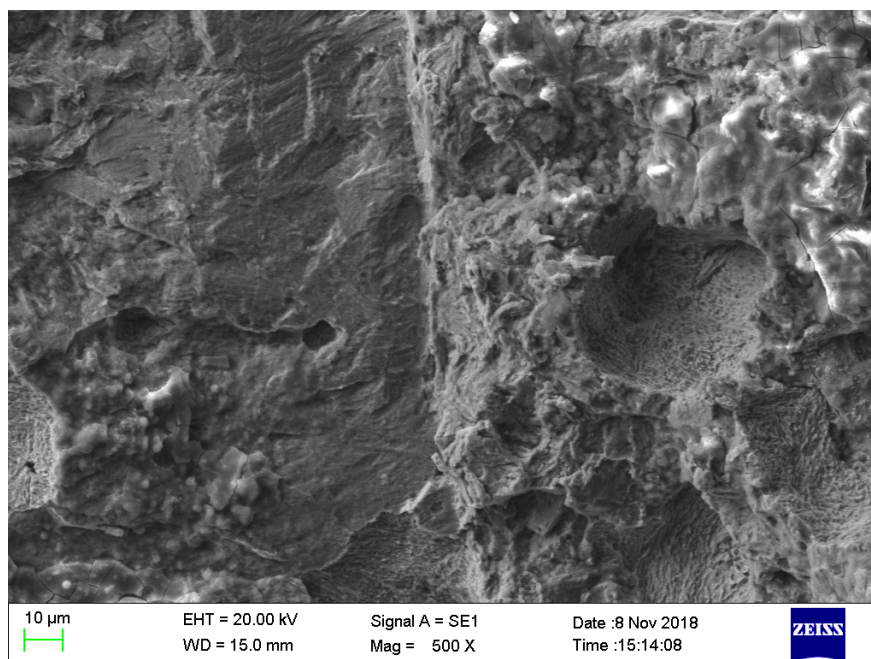
Fig.14 Instantaneous fracture area

The surface of the instantaneous fracture area is rough (Fig. 14), where the crack finally breaks rapidly, with many tear marks and a small amount of dimples, showing the micro morphology of quasi cleavage.
