Prosthetic Valve Leaflet Perforation resulting in Critical Aortic Insufficiency: A Rare Late Complication after use of COR-KNOT

Sankalp P. Patel¹, Robert J. Cubeddu¹, Stephen E. D'Orazio¹, and Brian J. Solomon¹ NCH Healthcare System

August 2, 2022

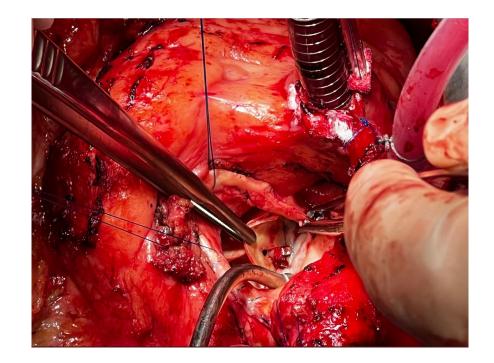
Case Report: A 70-year-old male (weight: 85kg, BMI: 28 kg/m²) with history of aortic stenosis underwent SAVR in 2015 at an outside hospital, 6 years prior to his presentation to our facility. He was noted to have no evidence of coronary disease and underwent successful implantation of a 23mm St. Jude Trifecta® bioprosthetic aortic valve at the outside center. Given use of a minimally invasive technique, the aortic prosthesis was secured with the Cor-knot[®] automatic fastening device. He presented to our institution in 2021, over 6 years after his initial SAVR, complaining of dyspnea on exertion which had worsened over the course of several weeks. His vital signs on arrival were significant for elevated blood pressure of 163/78 mmHg, revealing a widened pulse pressure. He underwent a two-dimensional transthoracic echocardiogram (TTE), revealing an LVEF (left ventricular ejection fraction) of 40-45%, mild to moderate mitral valve regurgitation, and an abnormally functioning bioprosthetic aortic valve. Dimensionless index via doppler interrogation was noted to be 0.34, however pressure half-time was noted to be less than 250 milliseconds, thus quantifying severe transvalvular aortic regurgitation. Given reduced LVEF, he underwent cardiac catheterization with unremarkable coronary occlusion noted. Subsequent transesophageal echocardiogram (TEE) was performed to elucidate true severity of bioprosthetic valve dysfunction and confirmed compromised severe transvalvular aortic insufficiency with revelation of a torn non-coronary leaflet (Video 1). Surgical removal of the malfunctioning bioprosthetic valve and redo-SAVR was planned the following day. The patient was brought to the operating suite in a fasted state and prepped and draped in usual sterile fashion. He was cannulated for cardiopulmonary bypass without complication. Re-do aortotomy was planned a quarter centimeter above prior aortotomy line with extension across the noncoronary sinus and coronary ostial cardioplegia was needed given severity of aortic insufficiency. Upon initial visual observation, decision was made to proceed with an aortic root enlargement to facilitate placement of a properly sized valve via a Manougian approach, which proceeded to occur in uncomplicated fashion. Exposure of the 23mm St. Jude Trifecta® aortic valve ensued in the interim, confirming suspicion on TEE. A large circular hole was observed in the left coronary leaflet and another large similar sized hole was seen in the noncoronary leaflet (Figure 1). Both holes corresponded to inward facing metallic Cor-knot[®] fastened knots, likely precipitating leaflet perforation. Uncomplicated valve resection followed thereafter along with completion of annular enlargement, with post-explant visualization of the St. Jude Trifecta® better unveiling the 2 separate perforations created in the left and non-coronary cusps, aligning with the position of metallic fastened knots (Figure 2A and 2B). A 23mm On-X[®] (CryoLife, Inc.) mechanical valve was implanted in the aortic position. After confirming successful valve placement, a bovine pericardial patch was utilized to close the aortotomy and routine weaning of bypass ensued followed by decannulation. The patient was brought back to our cardiovascular intensive care unit and follow-up echocardiogram showed a well-seated mechanical aortic valve without significant valvular or paravalvular regurgitation (Video 2).

complications of the fastening device remain poorly understood. The St. Jude Trifecta® aortic bioprosthesis was implemented in our patient in 2015; recent data has demonstrated this valve has necessitated reintervention more often than other bioprostheses³. Whether the durability of the Trifecta® valve contributed to the perfectly round perforations in both leaflets is unable to be determined, but it can be presumed that bioprosthetic valve deterioration may have had a role. Severe transvalvular aortic regurgitation after implementation of a Trifecta® (St. Jude, Inc.) prosthesis in conjunction with the Cor-knot® has been scarcely reported. Several reports exist demonstrating severe bioprosthetic transvalvular regurgitation from a similar causative mechanism in other SAVR prostheses, though the patients within these reports presented within 20 months of valve replacement^{4,5}. As highlighted within these reports, we believe the mechanism of leaflet failure in our patient was due to repetitive trauma suffered by the leaflet as it consistently flapped against the Cor-knot®.

Our report serves to highlight an underreported and poorly understood mechanism of bioprosthetic aortic regurgitation secondary to leaflet trauma from an automated titanium fastening device. We recommend operators to remain vigilant of this complication before utilizing artificial knot-fastening systems and to orient knots away from imposing neighboring leaflet impedance.
