Analysis on corrosion fatigue cracking mechanism of 17-4PH blade of low pressure rotor of steam turbine

Accident unit was put into operation in September 2016. The steam turbine (Model: CLN350-24.2/566/566) is supercritical, primary intermediate reheat, single shaft, single back pressure, wet condensing steam turbine produced by Harbin steam turbine works Co., Ltd., which has the operation capacity of steam extraction with heat supply. The unit has started 12 times since it was put into operation, and entered into overhaul in late June 2018.

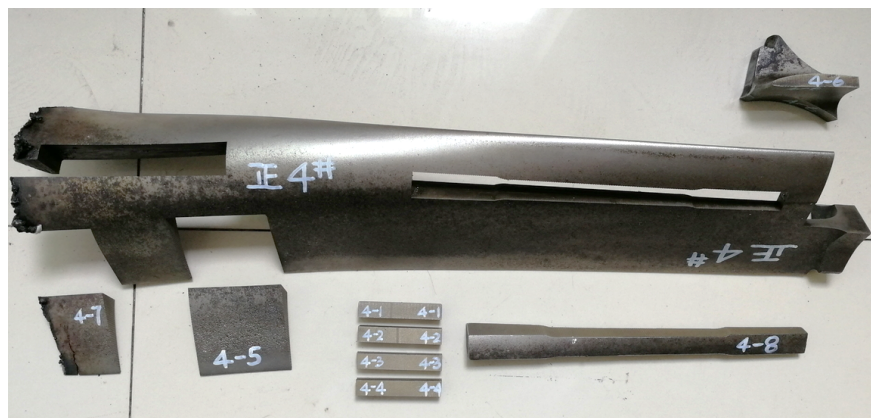
Fig. 5 Sampling(among them, 4-5 is the element analysis sample, 4-6 is the metallographic sample, 4-8 is the tensile sample, 4-1, 4-2, 4-3, 4-4 is the impact sample)

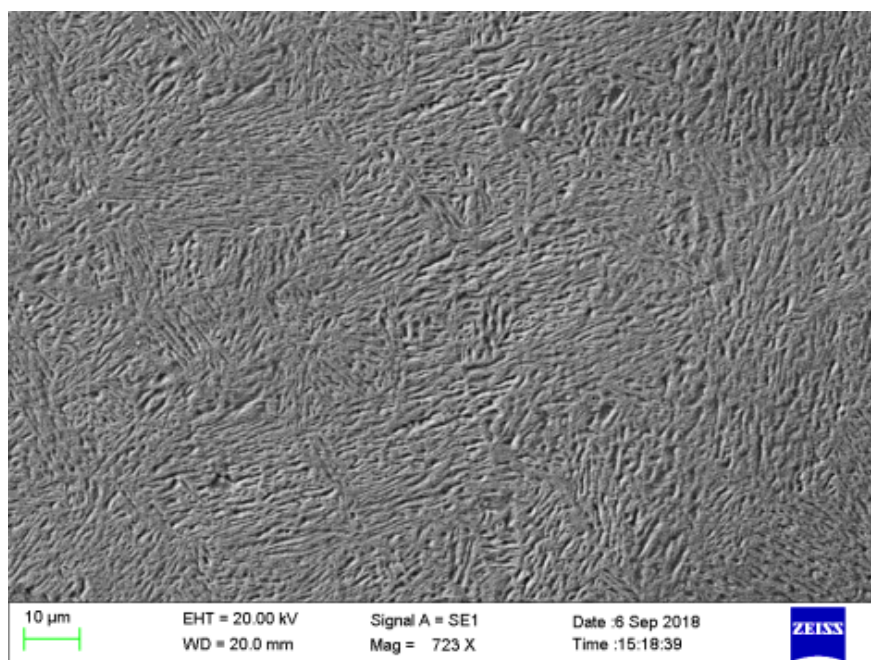
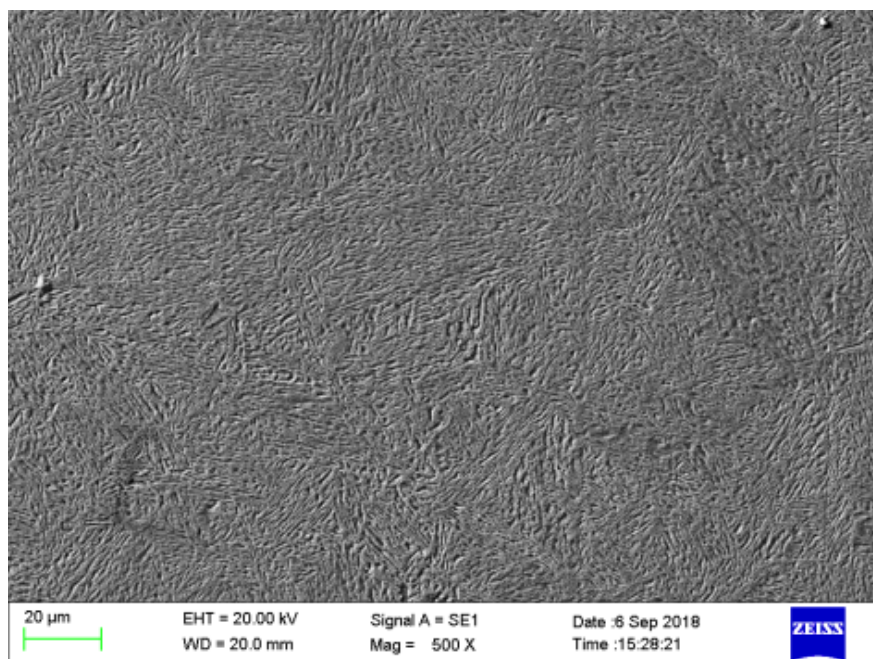
According to GB /T13298-2015 *Test method for microstructure of metal* , after mechanical polishing, picric acid + hydrochloric acid are used for erosion, and then metallographic analysis is carried out for the cracked blade section. The microstructure was analyzed by metallographic microscope and scanning electron microscope(SEM). The results(Fig. 6, Fig. 7)show that the microstructure is low carbon martensite + dispersed intermetallic strengthening phase, the matrix structure is normal, and there are many fine branch cracks along the grain near the main crack.

Fig. 7 Microstructure by SEM
