Vulnerability Assessment of Bridges Exposed to Scour in a Multi-Hazard Environment by UAV Measurements

VULNERABILITY ASSESSMENT OF BRIDGES EXPOSED TO SCOUR IN A MULTI_HAZARD ENVIRONMENT BY UAV MEASUREMENTS

IMPORTANCE & AIM OF THE STUDY

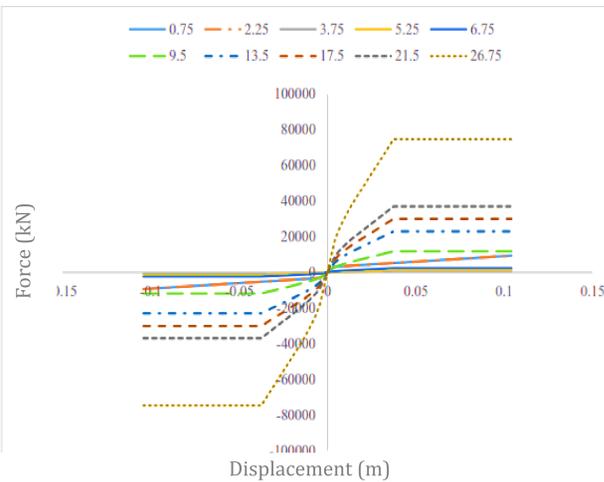
- The nonlinear soil spring properties at pile half-length for sand layers before scouring -

The soil-pile foundation-structure interaction was implemented in the finite element models of pile groups.

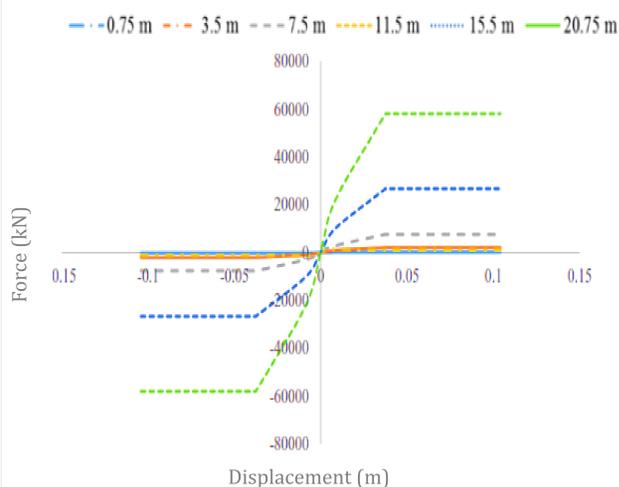
- The nonlinear soil spring properties at pile half-length for sand layers after scouring -

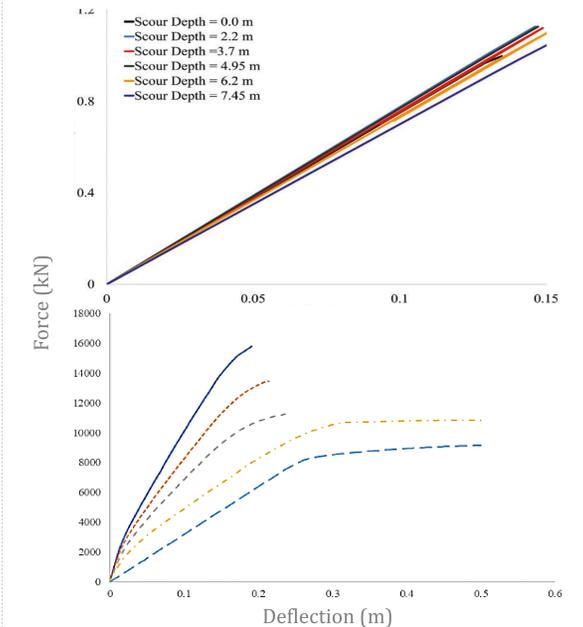
- Pushover curves in X-direction-

The amount of scour occurred in bridge piers was determined realistically, and the behavior of bridge under scour effects was investigated. In the light of the attained scour measurements and expected scour after a probable flood event, the behavior of scour induced RC bridge was determined by pushover analyses under seismic loadings.

Six different scour depths concentrated only on the mid piers was observed to have a negligible influence on the modal characteristics and the lateral performance in the longitudinal direction regarding lateral stiffness and strength.

The performance points were evaluated regarding four methods as described in the guidelines of ATC-40 (Applied Technology Council, 1996), FEMA- 356 (Council B.S.S., 2000), and FEMA-440 (Federal Emergency Management Agency, 2005) (for Equivalent Linearization method – FEMA-440EL and Displacement Modification method – FEMA-440DM).

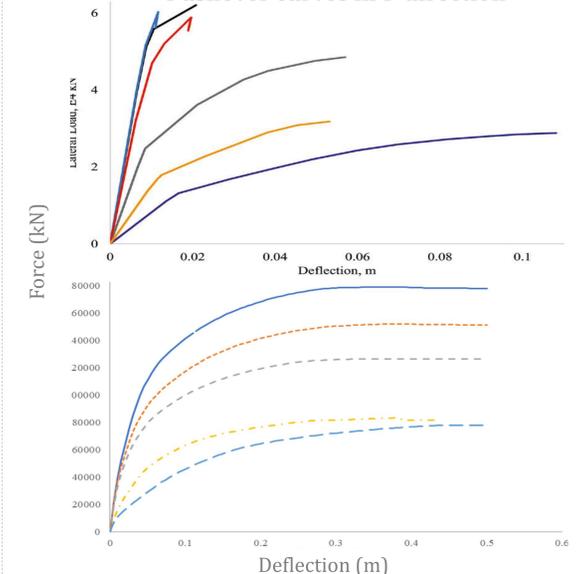
- Pushover curves in Y-direction-
