# Surface water availability and field-measured permeability on Santa Rosa Island, Channel Islands National Park, California

Kevin Schmidt<sup>1</sup> and Scott Minor<sup>1</sup>

<sup>1</sup>U.S. Geological Survey

November 23, 2022

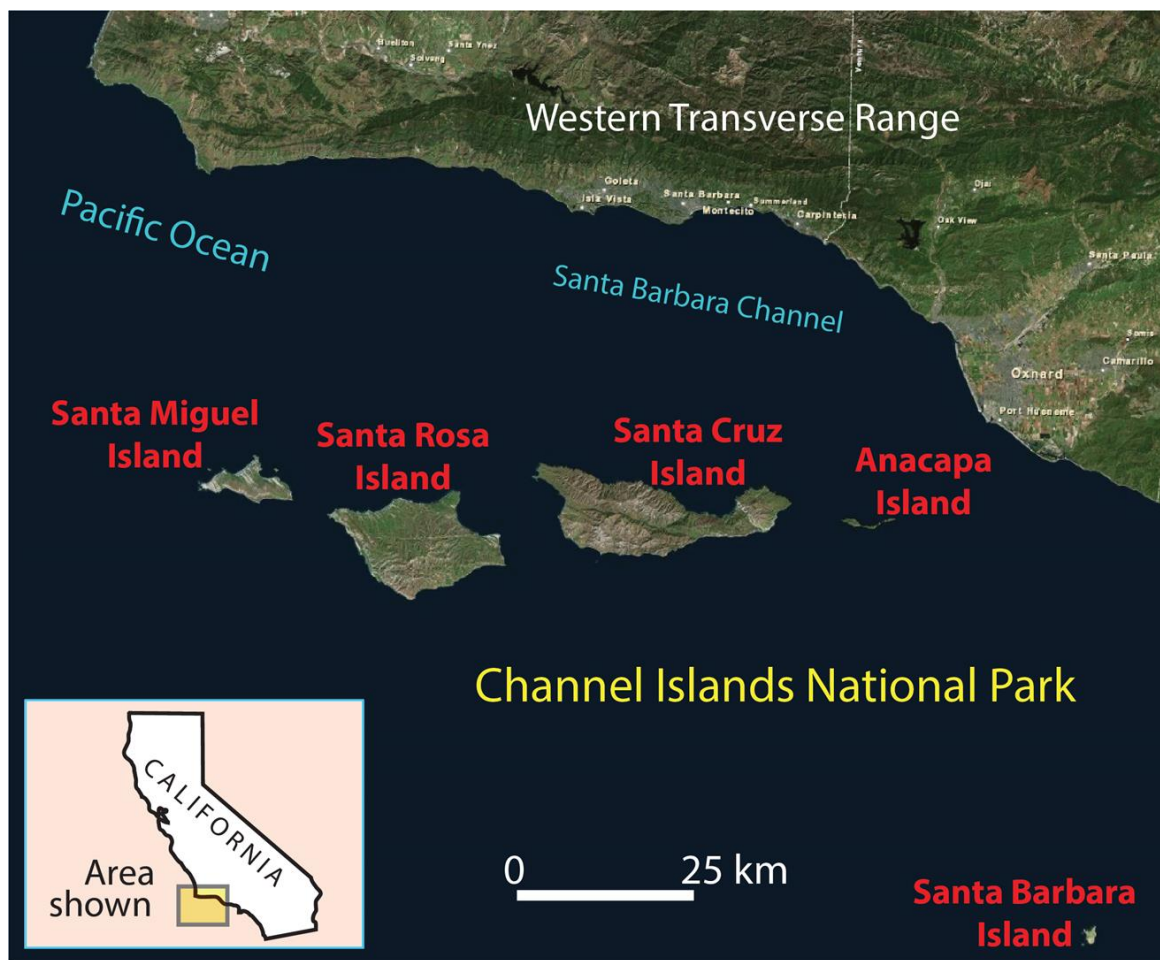
**Fig. 3.** The five islands (labeled in **red**) of Channel Islands National Park are located ~20-60 km offshore of southern California.

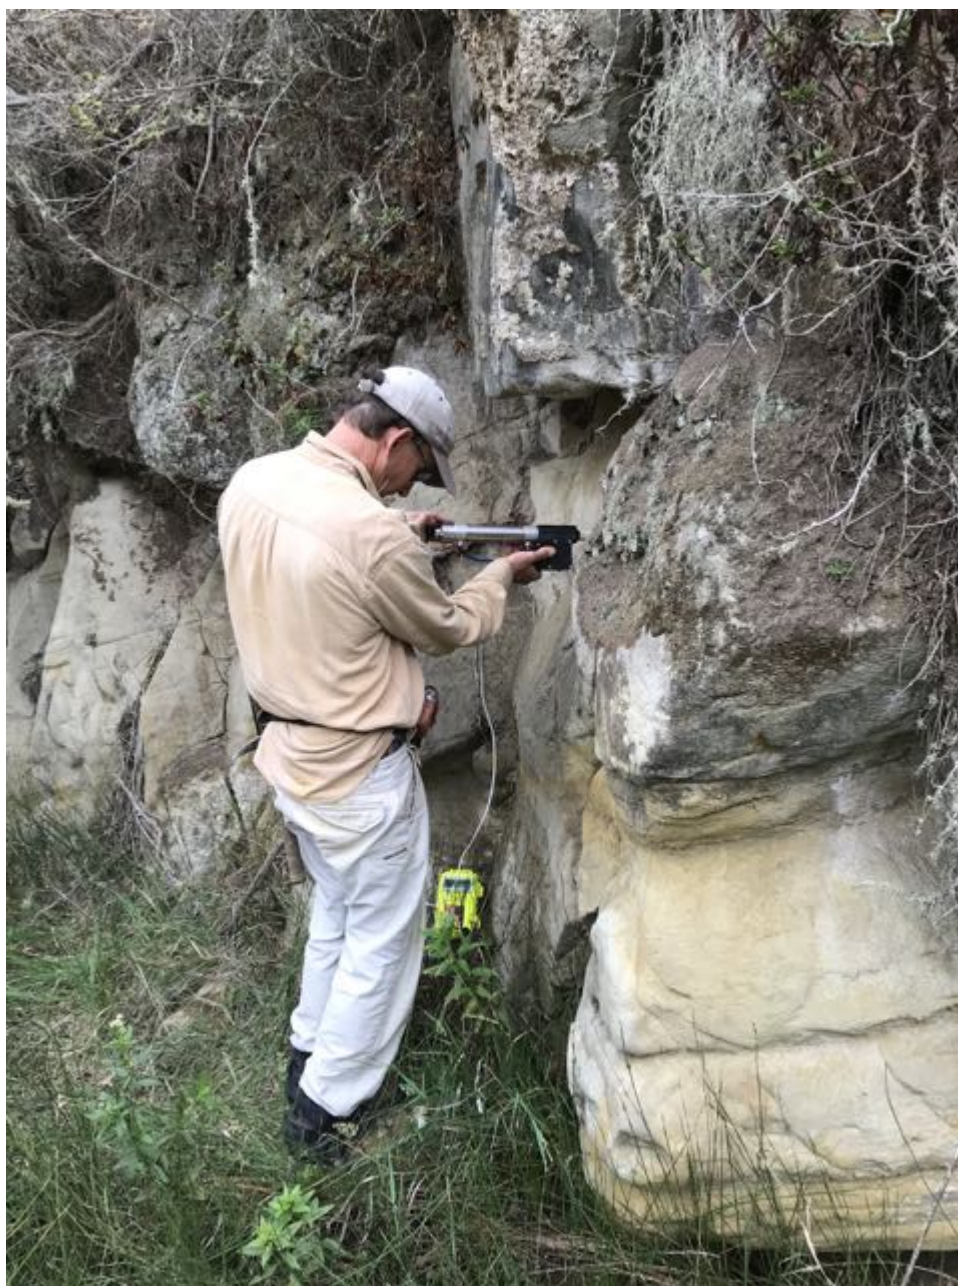
**Fig. 5.** Measuring permeability of marine sedimentary bedrock using TinyPermII field instrument. Author (Minor) waiting for permeability measurement to complete above channel bottom with surface water.

To operate the permeameter, a rubber-tipped nozzle is pressed against the earth material and air is withdrawn from the material with a single stroke of the syringe (Fig. 5). As air is pulled from the sample, a microcontroller unit simultaneously monitors the syringe volume and the transient vacuum pulse created at the sample surface to estimate material permeability. Numerous

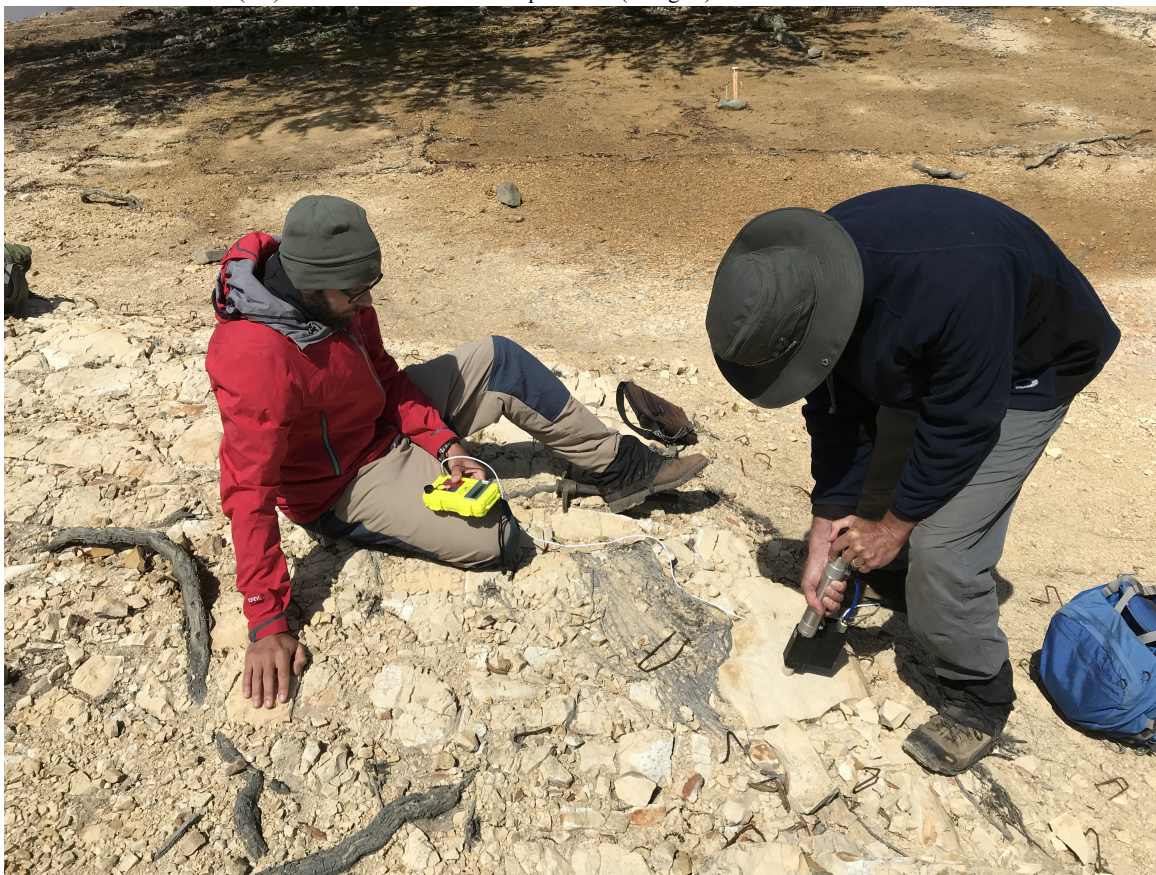
**Fig. 8.** Permeability measurement on older marine sedimentary rock with low primary permeability, but high secondary permeability from accompanying secondary fractures.

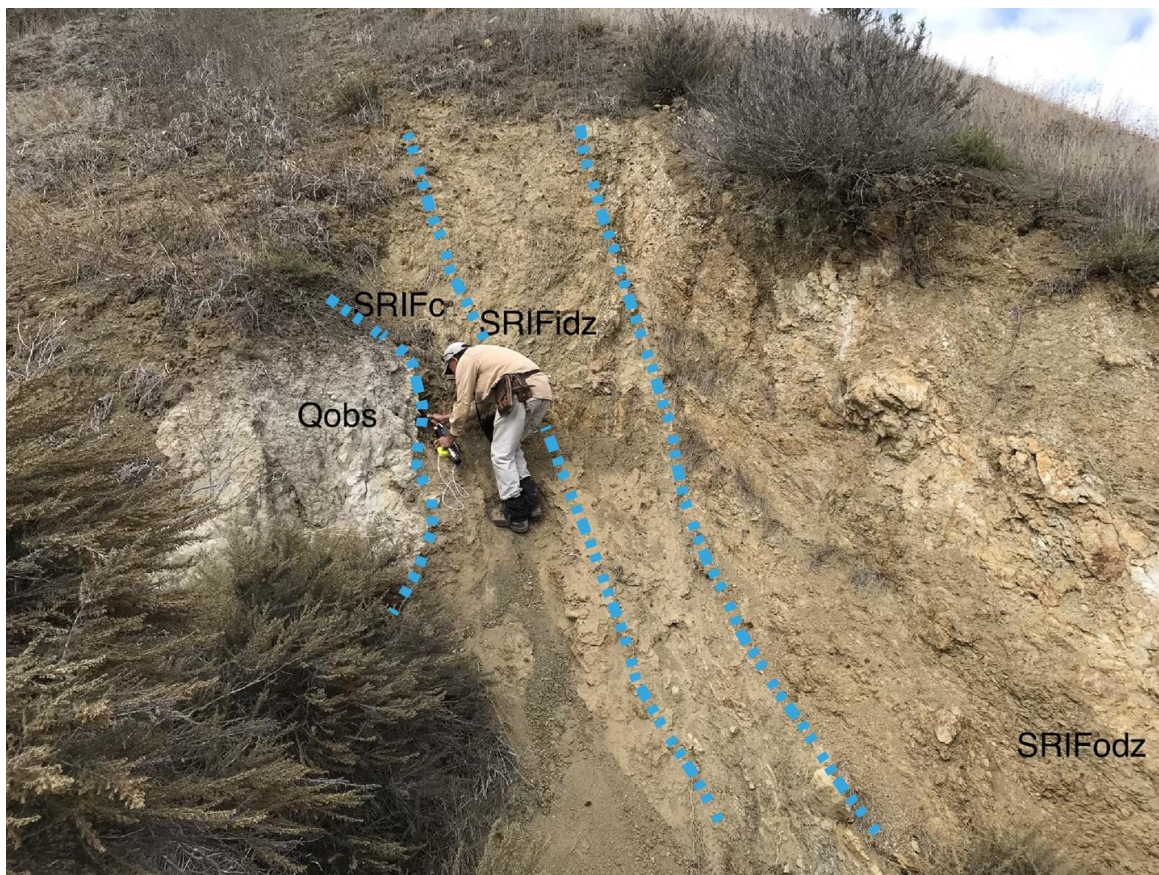
**Fig. 12.** Santa Rosa Island fault exposure juxtaposing old beach sands (Qobs), fault core (SRIFc), inner damage zone (SRIFdz), and outer damage zone (SRIFodz) of marine sedimentary bedrock. Dashed blue lines added to highlight unit boundaries. Author (Minor) taking permeability measurement in fault core.

- Faults can act as both conduits and barriers to groundwater flow
- Laterally continuous fault-core gouge, and juxtaposition of rock types with contrasting permeabilities, act as effective barriers to cross-fault flow, forcing groundwater to the surface.

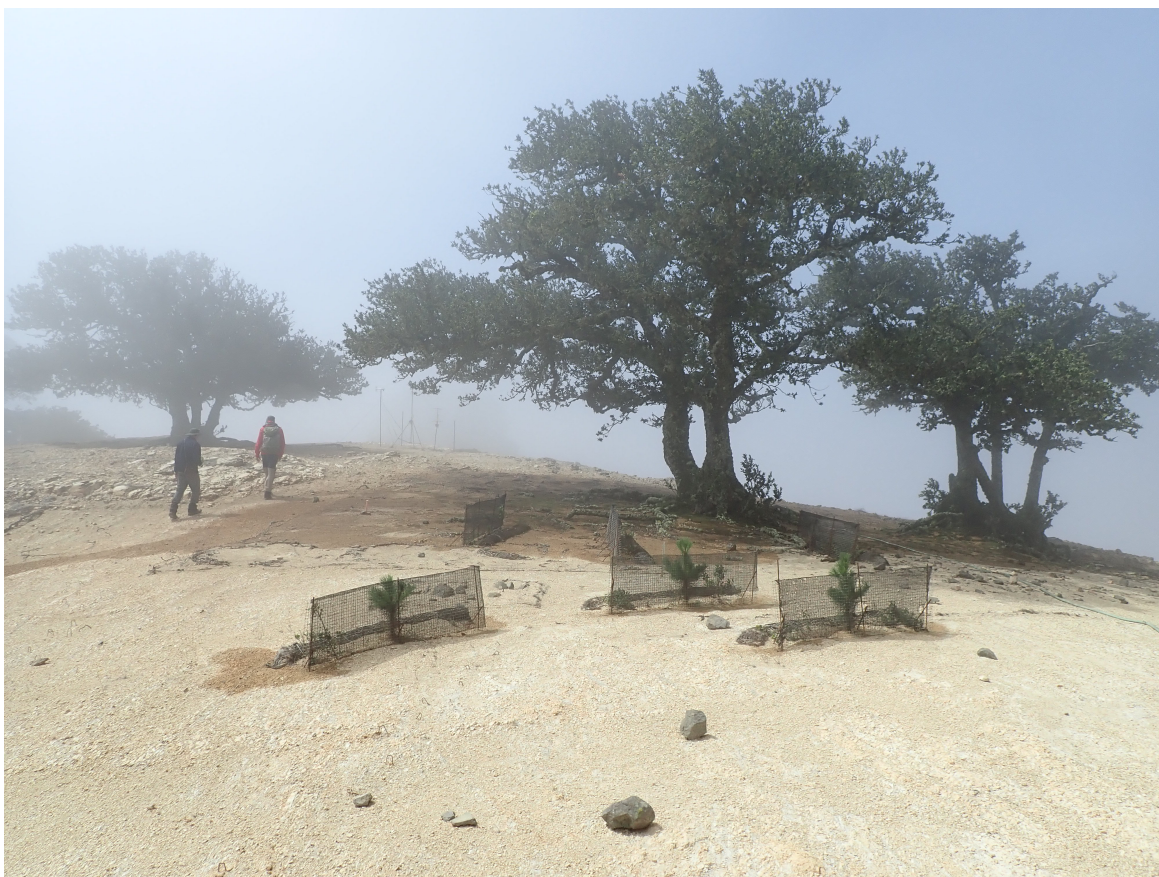
**Fig. 14.** Temporary "fog fencing" installed in "Cloud Forest" intended to trap fog drip, hence naturally watering restored native vegetation. Note darker wet patches adjacent to fencing and under Island Oak (*Quercus tomentella*) trees relative to lighter colored rock exposed by accelerated erosion from legacy grazing practices.
